UNIVERSITY
OF TASMANIA

INTEGRATION OF GEOTECHNICAL AND STRUCTURAL DATA FROM SAVAGE RIVER MINE, TASMANIA

Doctor of Philosophy

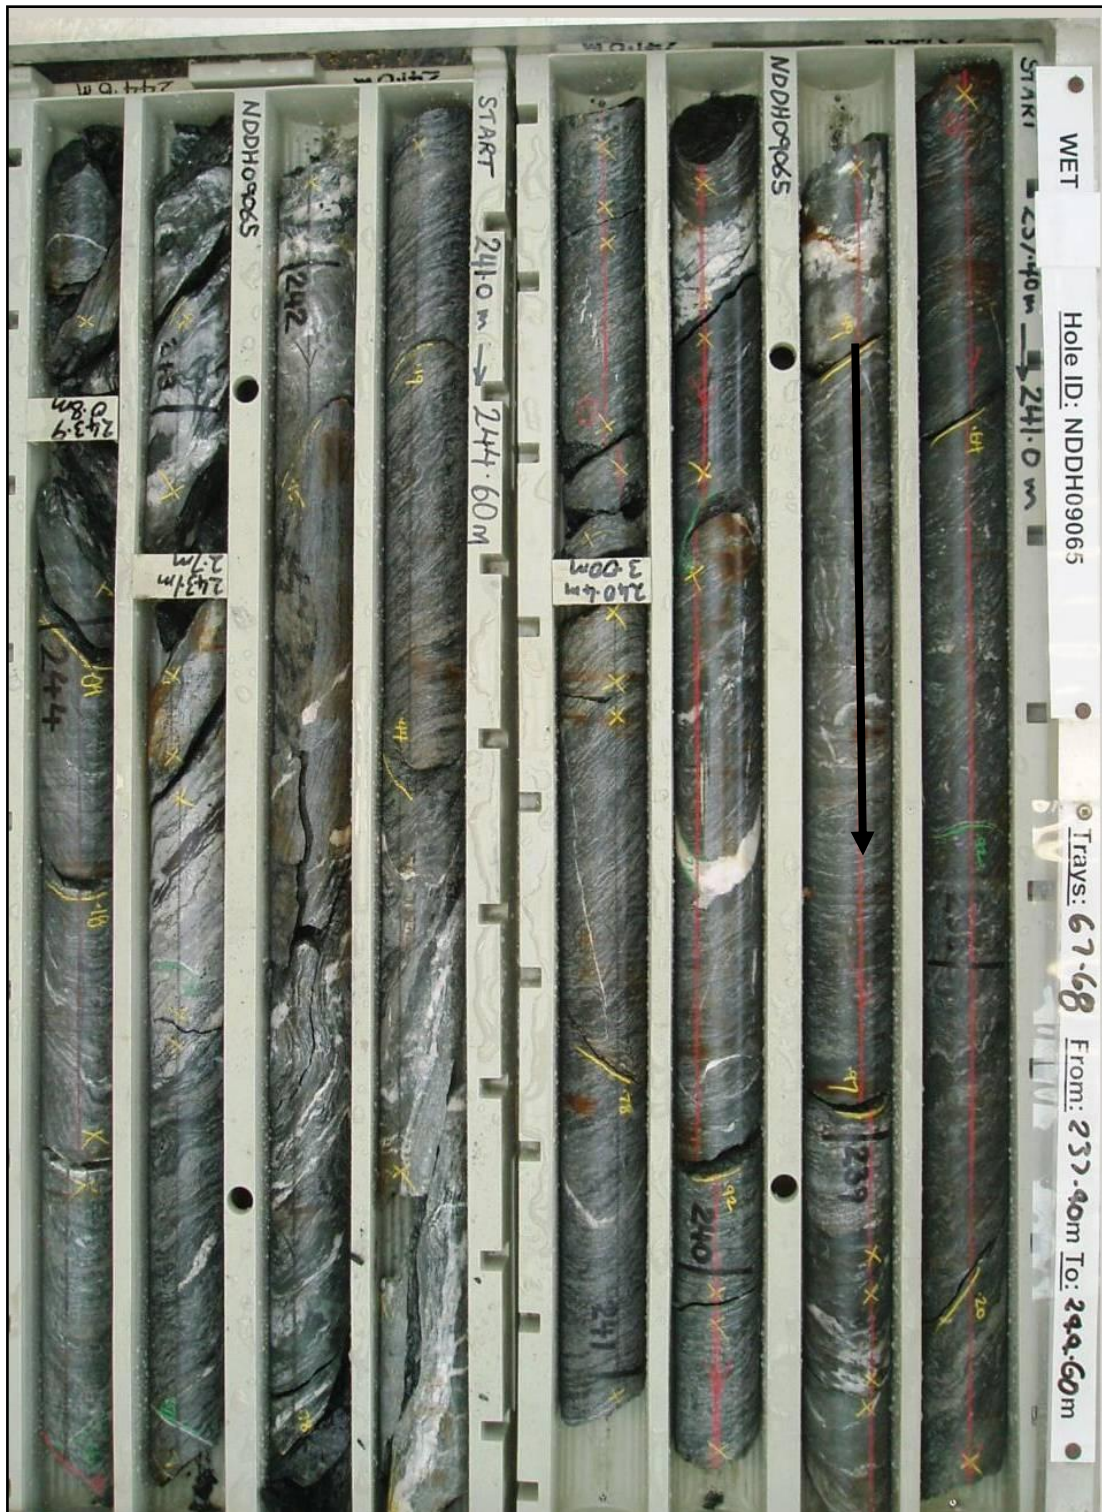
Figure 3.40. Example of foliation within NDDH09065 at 237.40m to 244.60m. The arrow denotes down-hole direction. Note how the foliation changes down-hole from weakly to strongly foliated. The core is HQ3 sized.

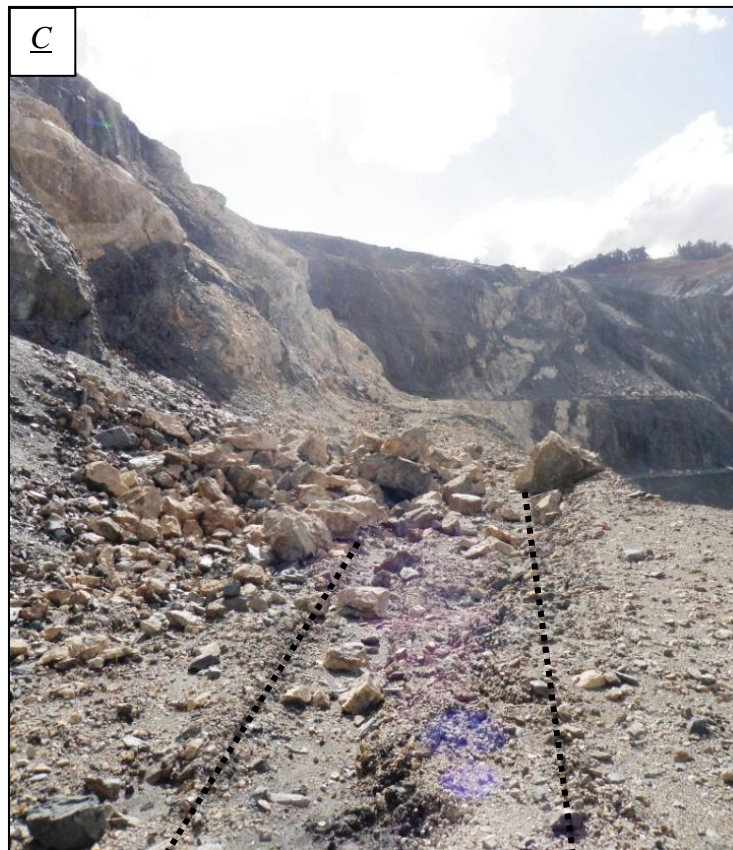
Figure 3.49 – Flexural toppling within the WWA. A – A cartoon drawing of the mechanism of flexural toppling. The bench slope angle is exaggerated. In reality, the inter-berm slope angle is approximately 60°. B – Interlayer sliding between rock columns resulting in a series of reverse scarps developing. C – Photograph of the 140RL berm, W wall of North Pit looking N. Dotted black lines denote tension cracks within the berm. Note that the berm is wide enough to catch the rock debris of the bench above. The berm is approximately 4m wide at this point.

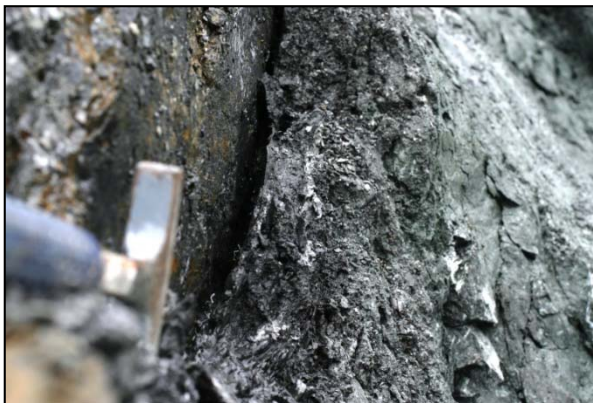
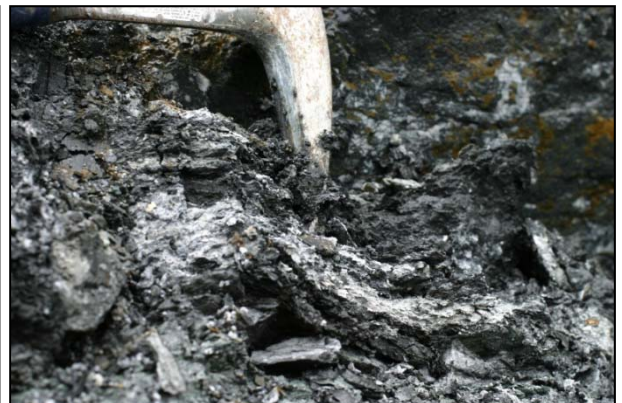
Figure 3.59. A –The Eastern Splay Fault highlighting the October 2009 rock fall area (dashed red line). Looking SE. B – The aperture along the fault plane. C – Puggy gouge at the fault plane.

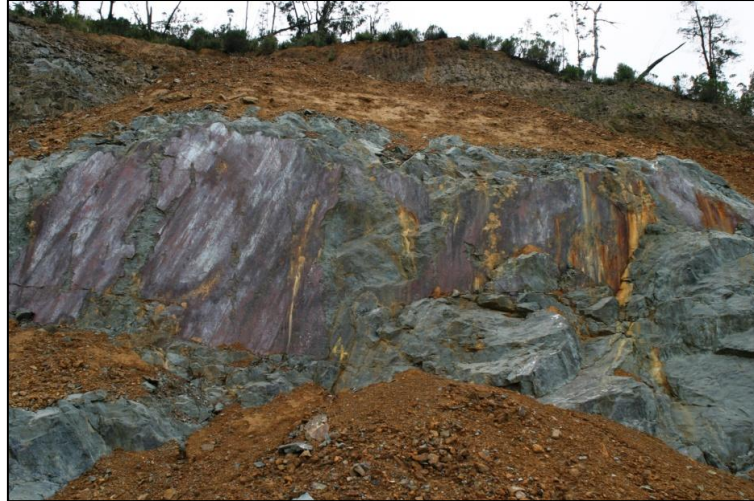
Figure 4.1. An example of a late hematite coated fault with striations cutting off other features.

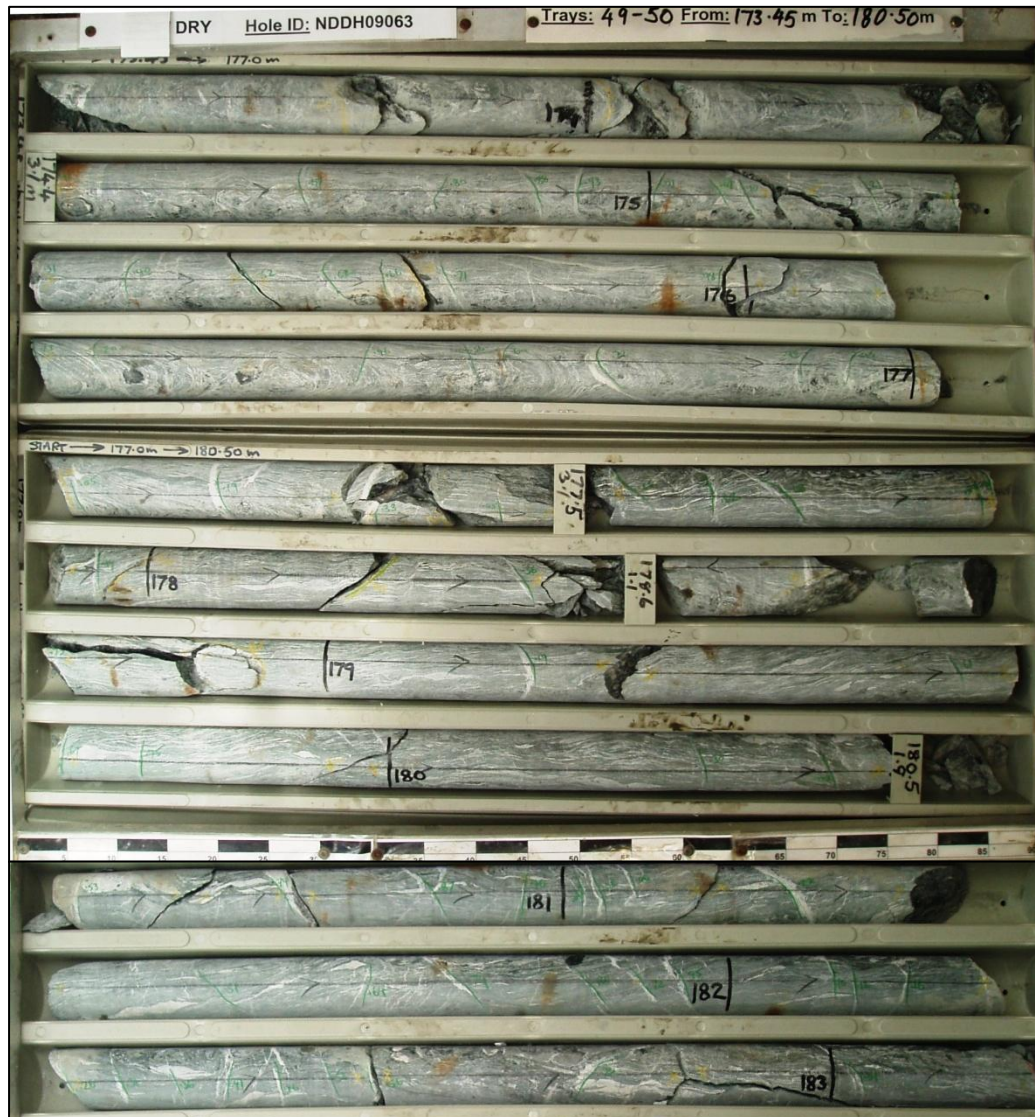
Figure 4.21. NDDH09063, 173.45 m to 183.30 m. An example of possible mylonitic fabric ignored by the GSI method. This drillcore was designated a B3 GSI rating although it is an indicator of a ductile fault in the area.

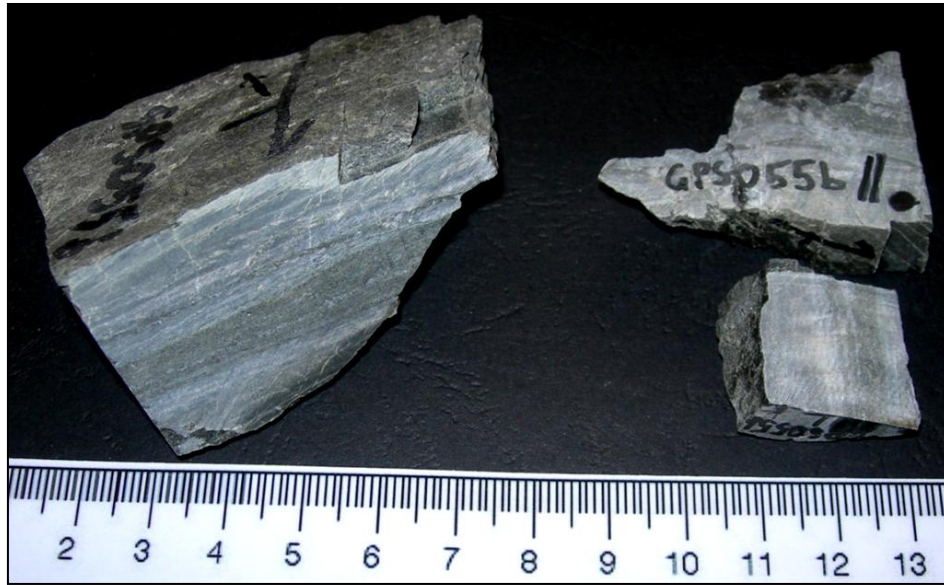
Figure 5.13 – Hand specimen of oriented sample 176637 and corresponding thin section cuts. This presents a strong (micro) mylonitic fabric and interpretable shear sense indicators. Scale in cms.

All oriented samples were cut perpendicular to the mylonitic foliation and parallel to the stretching lineation and also parallel to the mylonitic foliation and normal to the stretching lineation (Figure 5.13). The thin sections cut parallel proved suitable to determine shear sense (Figure 5.14). Additional mineralogy information of the matrix and porphyroblasts composition was gained using the thin sections cut normal to the stretching lineation.
